H200[®] Wireless

TROUBLESHOOTING GUIDE

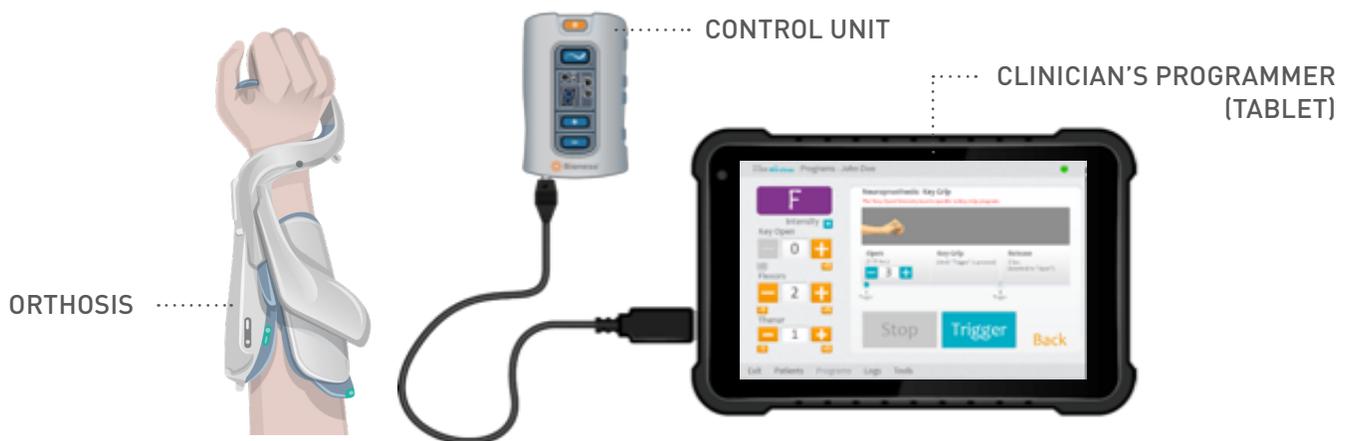
This may occur due to disruption in wireless communication between the Orthosis and the Control Unit and cause the H200 Wireless Software to exit the program to the Menu or Patient Selection Screen. If a pop-up appeared after communication disruption, try Solution 1. Otherwise, try solution 2.

If there is communication loss between the Orthosis and Control Unit or Clinician's Programmer, try the following:

1. Verify that the wired connection between the Control Unit and the tablet is secure.
2. Place the tablet on a stationary surface.
3. Doff the Orthosis to prevent stimulation from continuing.
4. Inspect the USB port or cable for damage. Use another cable if available.

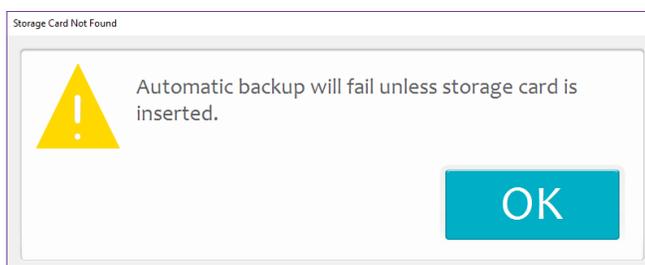
MicroSD CARD IS CORRUPTED

1. Neither the loading screen nor the login screen appear when launching the **H200 Wireless** Software, even after minutes of waiting.
2. An error message indicating a problem with the backup database appears when launching the H200 Wireless Software.
3. A pop-up in the lower right corner of the screen indicating that there's a problem with the E drive.
4. A Microsoft Windows **"initialization"** error appears when launching the **H200 Wireless** Software:
"An Error has occurred in the program during initialization. If this problem continues, please contact your system administrator."

Solution 1: Order a New MicroSD Card through Salesforce
